# Fire Resistance of Composite Beams with Restrained Superposed Slabs

To investigate the fire resistance of composite beams with restrained superposed slabs, three specimens were tested under uniformly distributed loads in a furnace. The effects of the thickness of the postcast top layer in superposed slabs and the spacing of shear studs on the structural behaviours of composite beams under fire were further examined. During the tests, the temperature distributions of the superposed slabs and steel beams as well as the displacements at their key positions were recorded and analysed. It was found that the temperature of the concrete superposed slabs decreased long their heights from the bottom. The most drastic change of the temperature along the slab cross section was found in the region with a distance of 40 mm to the slab bottom. The concrete superposed slabs could impose restraints to the steel beams due to their incompatible deformations. Cracks were developed on the top surfaces of the specimens and the superposing interfaces between the precast slabs and postcast top layers were not broken. Through the comparisons of different specimens, the spacing of shear studs could have

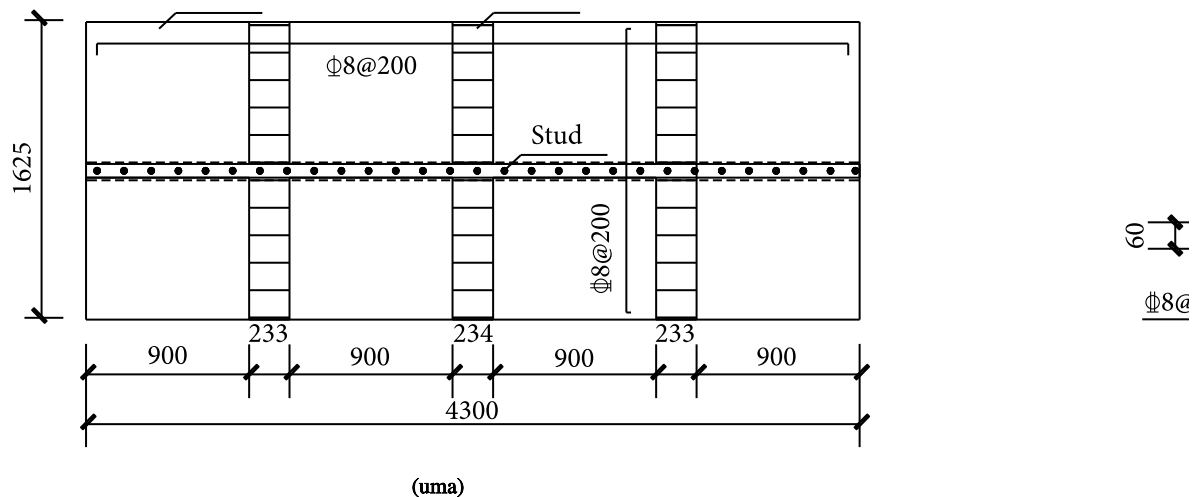
**figura 1**

Detalhes da amostra: (a) vista em planta e (b) vista em corte (unidade: mm).

Três corpos de prova de vigas mistas com lajes sobrepostas (SCB-1–3), consistindo de uma viga de aço, lajes sobrepostas de concreto e pinos de cisalhamento, foram projetados e fabricados de acordo com as normas de engenharia relevantes. O comprimento total das vigas mistas foi de 4.300 mm e a largura dos banzos foi de 1.625 mm. As lajes sobrepostas de concreto foram compostas por uma camada base pré-moldada de 60 mm de espessura e uma camada superior pós-moldada. O grau nominal de concreto para

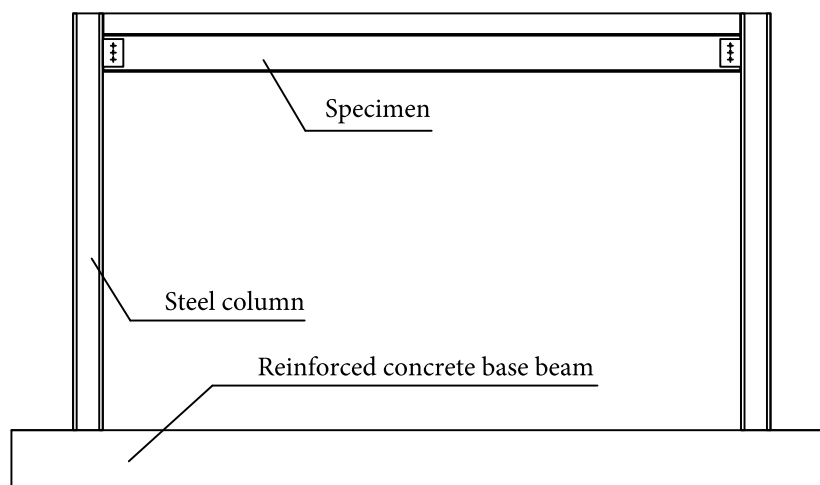
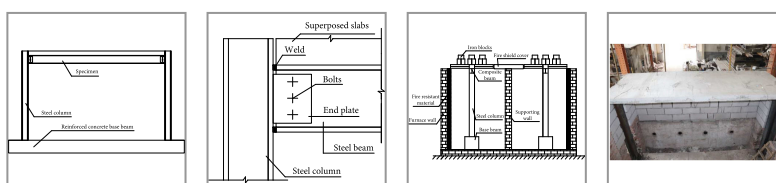
Os testes foram realizados no Laboratório de Incêndio da Universidade Shandong Jianzhu. O forno foi modificado com base nos requisitos do teste e permitiu que dois espécimes fossem testados ao mesmo tempo. Para contenção dos corpos de prova, uma viga de base de concreto armado e dois pilares de aço (Figura 2(a)) foram fabricados e montados. Durante os testes de fogo, eles foram cobertos por lã mineral resistente ao fogo. Os pilares de aço tinham 2.800 mm de altura e eram fixados à viga de base por meio de pinos de aço. Essas colunas foram feitas de aço Q235B e suas dimensões seccionais foram HN 200 mm × 200 mm × 8 mm × 12 mm. Os corpos de prova foram totalmente fixados às colunas de aço por meio de parafusos M22 de alta resistência ao atrito e placas de extremidade de aço que tinham dimensões de 210 mm × 160 mm × 10 mm (Figura 2(b)). A configuração de teste e o corpo de prova de viga mista pronto para teste são mostrados nas Figuras 2(c) e 2(d), respectivamente.

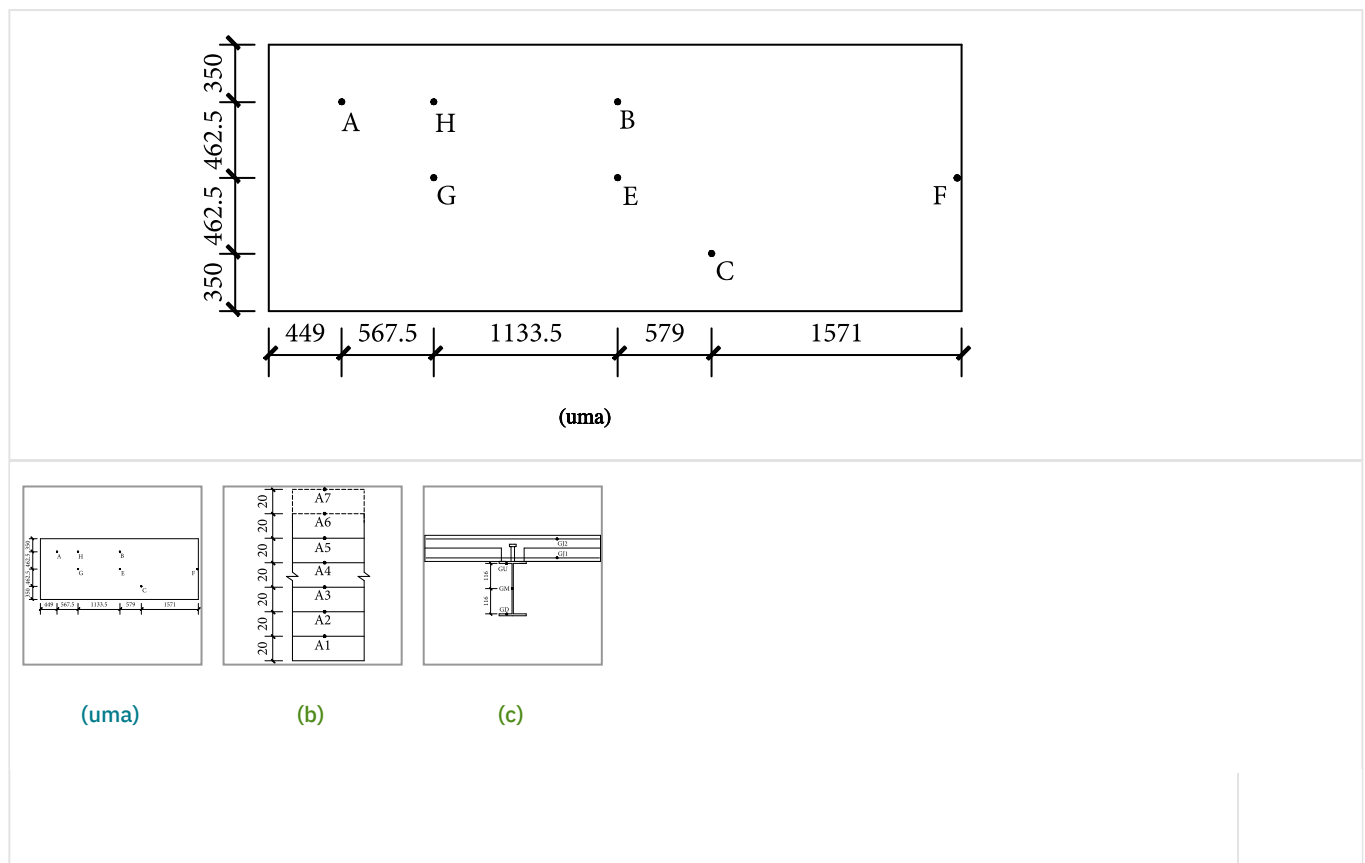
**Figura 3**

Temperature measurement positions: (a) plan arrangement, (b) measurement positions for concrete, and (c) measurement positions for rebars and steel beams.

A distribuição de temperatura e os deslocamentos da viga mista foram medidos durante os ensaios de incêndio. As temperaturas foram medidas em sete locais (A–C e E–H) dos corpos de prova. Especificamente, os termopares nas posições A–C e H monitoraram as temperaturas do concreto e vergalhões, enquanto os termopares nas posições E–G mediram as temperaturas do concreto e das vigas de aço. Para o concreto, os termopares foram dispostos com espaçamento de 20 mm na direção da espessura da laje. Além disso, as temperaturas foram medidas para as camadas superior e inferior de vergalhões, banzos superior e inferior de vigas de aço e alma de vigas de aço. Os detalhes da posição de medição são mostrados na Figura 3.

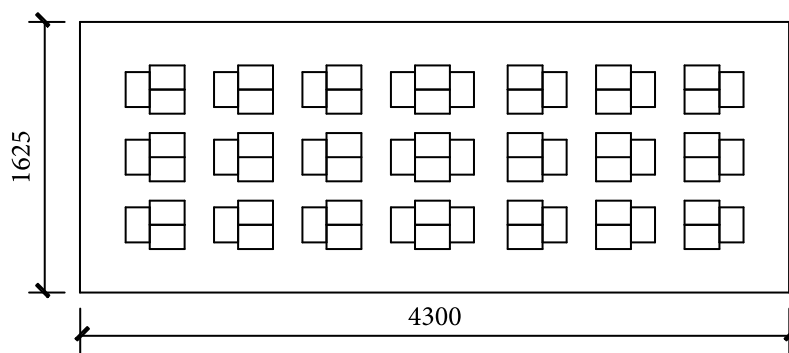
### Figure 5

Layout of the iron blocks.

In the test, two layers of iron blocks were placed on the top surface of the specimens to simulate a uniformly distributed load (UDL) of  $3.5 \text{ kN/m}^2$ . Figure 5 shows the layout of the iron blocks. After the UDL was applied, the specimens were heated according to the standard ISO-834 temperature curve.

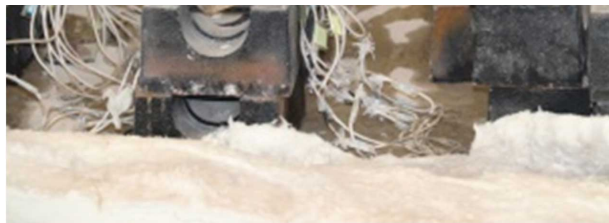
**Figure 6**

Failure modes of SCB-1: (a) water bay, (b) cracks on the top surface of the slab, and (c) local bursts on the bottom surface of the slab.

The tested specimen was passively cooled to a room temperature condition, during which no abnormal incident was observed. The main failure characteristics were as follows. (1) A large crack, as shown in Figure 6(b), on the top surface of SCB-1 extended from one end of the composite beam toward its midspan with gradually narrowed crack width. The maximum width of the crack was about 1 mm. (2) Vertical cracks were developed on the two longitudinal sides of the concrete slab and mainly concentrated above the superposing interface. Moreover, they were also observed in the postcast joint areas. (3) Vertical cracks appeared on the two transverse sides of the concrete slab and they were mainly distributed above the steel beam. (4) No cracks were observed on the bottom surface of the concrete slab yet local bursts happened (Figure 6(c)). (5) At the end restraints, the weld joint between the top flange of the steel beam and the steel column was torn, which might be the source of the loud sound during the test. An overall torsional deformation of the steel beam was also observed.

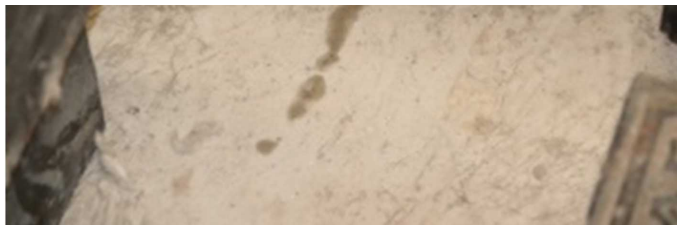
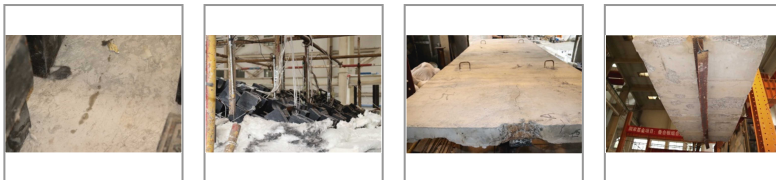
### Figure 7

Failure modes of SCB-2: (a) water spots, (b) severe out-of-plane instability of the slab, (c) cracks on the top surface of the slab, and (d) local bursts on the bottom surface of the slab.

Similar to the SCB-1, the failure modes of SCB-2 were examined after it was passively cooled to a room temperature condition. (1) The top surface cracks (Figure 7(c)) appeared from both ends of the slab and grew toward its midspan along the longitudinal direction. The same maximum crack width of 1 mm was also measured from the SCB-2 specimen. (2) Similar distribution patterns of the vertical cracks were developed on both longitudinal and transverse side surfaces of the concrete slab while local bursts (Figure 7(d)) also took place on its bottom surface. (3) In contrast with SCB-1, the weld joint for both top and bottom flanges of the steel beam fractured and produced the loud sound.

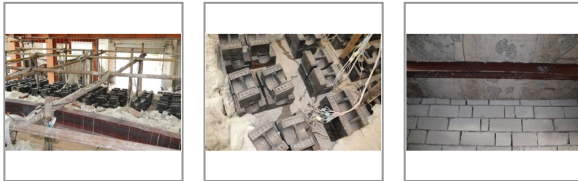
### Figure 8

Failure modes of SCB-3: (a) vertical deflection, (b) water spots, and (c) local bursts on the bottom surface of the slab.

The overall specimen vibrations, together with loud sounds, occurred twice after 9 and 12 minutes of the fire test. At 18 minutes, a noticeable vertical deflection (Figure 8(a)) at the midspan of the specimen was observed. At 29 minutes, water spots were observed at both ends and midspan of the specimen, as shown in Figure 8(b). At 32 minutes, the out-of-plane buckling was generated in the tested specimen and increasingly aggravated, which ultimately stopped the test at 92 minutes.

Compared to the other two specimens, local concrete bursts (Figure 8(c)) also occurred on the bottom surface of the superposed slab, yet a relatively longer crack with a 1,205 mm length was produced on its top surface. Moreover, the weld joint for both top and bottom flanges fractured, which led to an overall distortion of the steel beam.

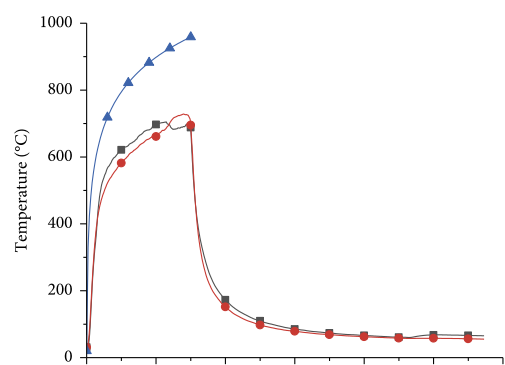
### Figure 9

Temperature field analysis of SCB-2: (a) comparison of temperature curves, (b) temperature changes at position A, (c) temperature changes at position B, and (d) temperature changes of the steel beam.

The comparison of the actual furnace temperatures of the two tests and the ISO standard heating curve is shown in Figure 9(a), which shows that the trends of the furnace temperature change fairly followed the ISO standard. The rapid temperature rise also suggests that the fire flashover was well simulated. The nearly identical furnace temperature curves of the two tests indicate that a similar temperature distribution in the three specimens could be achieved. The test results of SCB-2 are given below and analysed to present a typical thermal response of composite beams with superposed slabs.

As shown in Figures 9(b) and 9(c), owing to the thermal inertia of concrete, the temperature of the composite beam flange decreased along the height of the superposed slab section. The highest temperature was achieved at the bottom of the superposed slab, whereas the lowest one was found at its top. The most drastic change of the temperature along the slab cross section was found in the region with a distance of 40 mm to the slab bottom. With respect to the cooling, the temperature at the slab bottom went down faster than the ones at other regions in the same slab section. Due to the variation of the temperature distribution, a temperature gradient was produced along the thickness of the superposed slab. As a result, temperature stresses were generated within the slab and led to a tension effect in its top region. Such tensile temperature stresses, with the assistance of the bending moment due to the applied load, created top surface cracks along the longitudinal direction. Note that measurement position A in Figure 9(b) and position B in Figure 9(c) were at the superposed slab and the postcast joint, respectively. It is shown that the temperature gradients at these two positions were almost identical, which indicates that the superposing interfaces between the precast slabs and postcast top layers were not broken. In relation to the reinforcing bars, their temperatures were basically consistent with the surrounding concrete. The considerable temperature differences between the top (GJ2) and the bottom (GJ1) bars were mainly attributed to their distances to the source of the heat.

Figure 9(d) depicts the temperature changes measured at three positions on the midspan section of the steel beam. Specifically, EU and ED denote the measuring points on the top and bottom flanges, respectively, whereas EM denotes the measuring point on the web. The trends of three temperature changes were approximately the same and the maximum temperature of the steel beam was as high as 682°C. In the heating stage, the temperature of the top flange was lower than the other two positions as it was connected to the superposed concrete slab which absorbed a certain amount of the heat. In comparison, relatively less heat loss was caused on the web and the bottom flange of the steel beam as they were surrounded by hot air. In the cooling stage, the temperature of the bottom flange was lower than the ones of the other two positions. It is noted that the temperature of the concrete slab was higher than the one in the furnace due to its thermal inertia. Compared to the top flange and web, the bottom flange of the steel beam received less heat transfer.

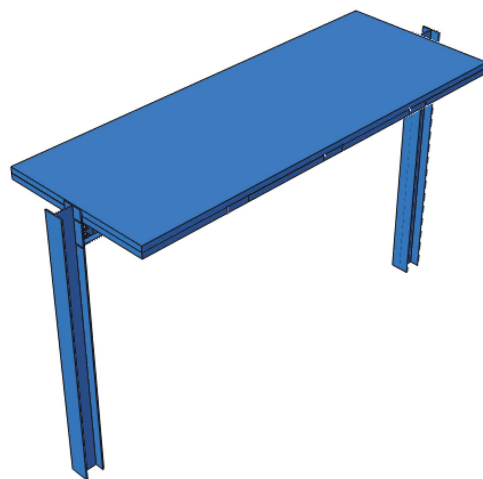
**Figure 12**

Numerical model of the composite beam specimens.

The temperature field simulation was conducted firstly, after which the loads and boundary conditions were applied. The stresses of the model in the temperature field simulation were introduced as the initial stresses for the followed thermomechanical coupling analysis. The bottom ends of the steel columns were fully fixed and a UDL of  $3.5 \text{ kN/m}^2$  was applied to the top surfaces of the superposed slab models. The numerical model of a typical composite beam with superposed slabs specimen is shown in Figure 12.

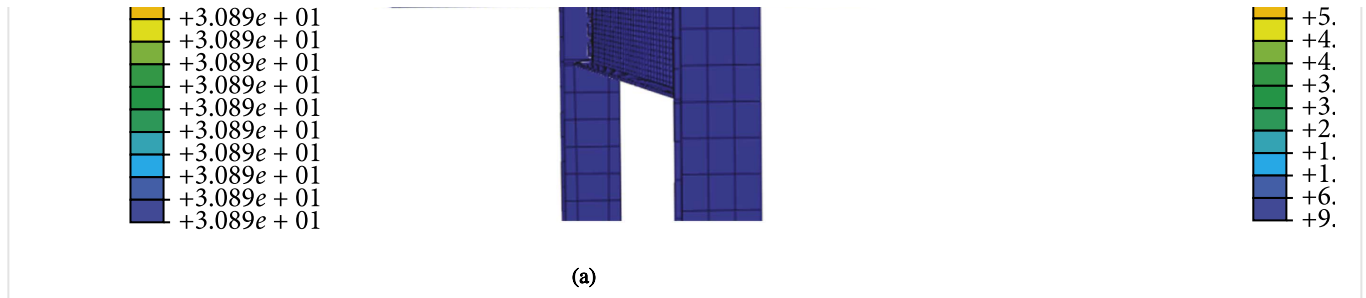
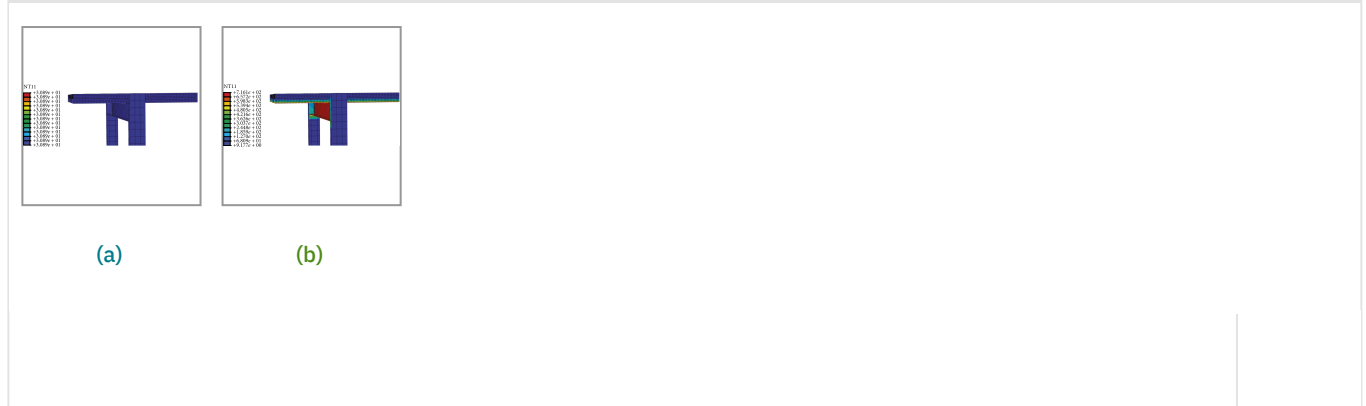
**Figure 13**

Temperature contours of SCB-2 (a) at 0 min and (b) at 75 min.
